LIGHTHOUSE ENGINEERING, L.L.C.

RE: Initial Engineering Evaluation – Foundation Performance
1234 Main Street
Dallas, Texas 75109

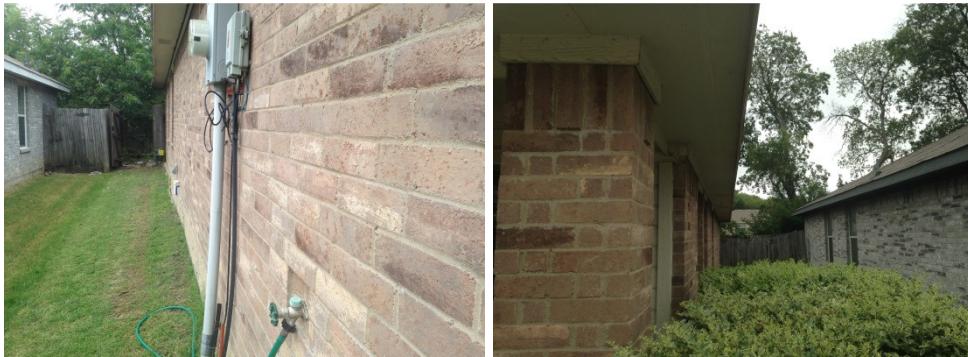
2. **Exterior Observations:** Indications of structural settlement and distress.
 - a. Brickline deflection on left and right sides (pictures 1 and 2).
 - b. Window separation and foundation cracking on right side at 20'. (pictures 3 and 4).

Pictures 1 and 2: Brickline deflection along the left and right sides.

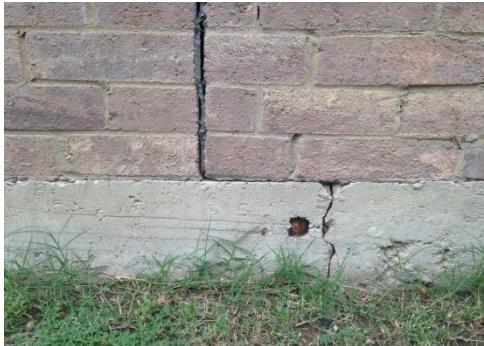
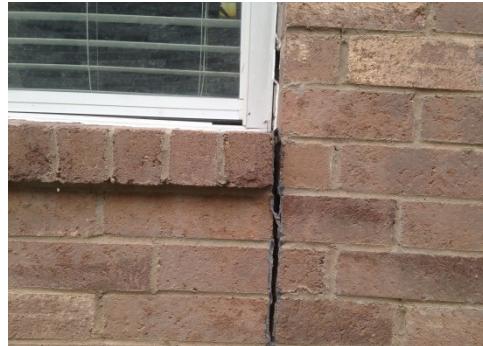
Pictures 3 and 4: Structural slab cracking and distress.

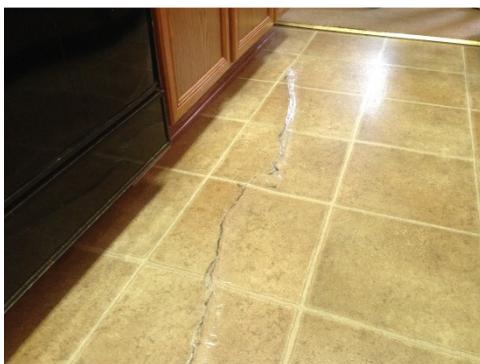
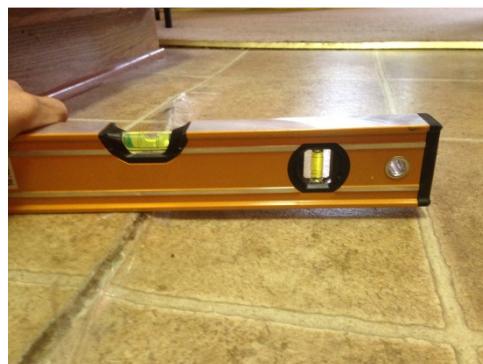
- c. Sheetrock crackings in various locations throughout the interior. Indicated settlement throughout the rear portion of the foundation.
 - d. Structural cracking that is indicative of foundation and PTI reinforcement failure throughout the kitchen. (pictures 5 and 6).

Picture 5 and 6: Structural cracking and distress. This cracking is indicative of structural failure of the concrete slab and PTI re-enforcement. This cracking has rendered the foundation unsafe, unsanitary or otherwise unlivable. I believe this cracking runs from left to right and can be seen at the exposed foundation.

- There is concrete cracking that indicates structural failure of the concrete slab and post tension re-enforcement. The foundation is no longer capable of supporting the superstructure.
- The magnitude and severity of the deflections and tilts in the foundation are causing load bearing components to be unsafe, unsanitary, or otherwise unlivable.

12. After the foundation is lifted to a more level position (or to the maximum extent practical), it is recommended to perform a port-to-port epoxy pressure injection structural crack repair on the visible cracking through the kitchen area. It is recommended to expose and repair the full length of this crack from left to right. It is recommended to use a Sikadur 35 Hi-Mod LV port-to-port epoxy or equivalent.

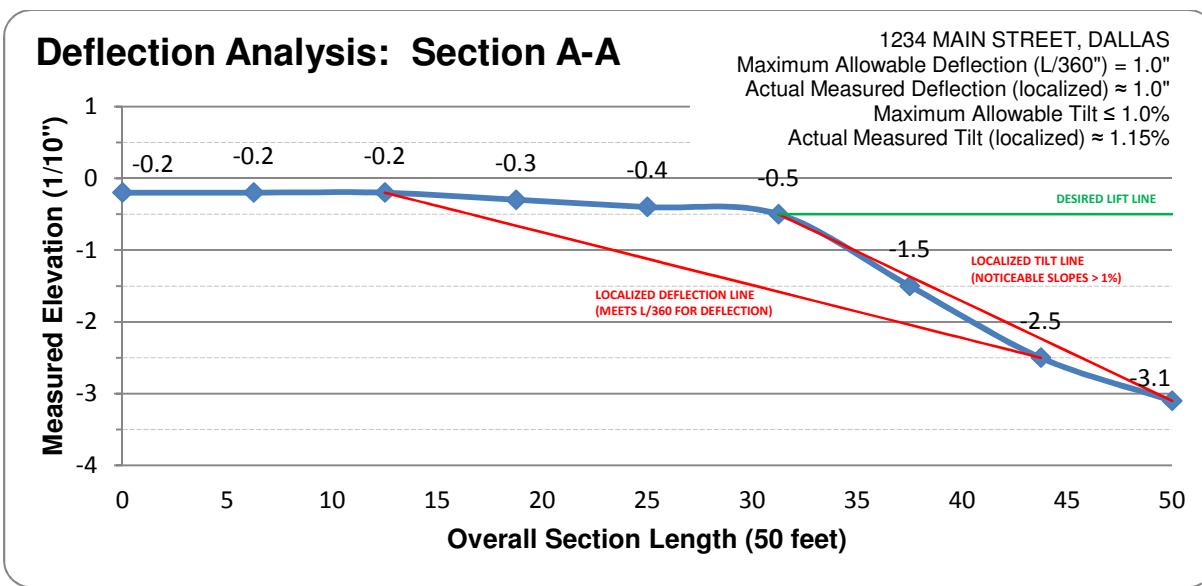
Figure 1: Deflection Analysis Cross Section A-A

6. **Elevation Analysis:** Industry standard tolerance for foundation performance (as defined by the Texas Chapter of the ASCE) is less than $L/360$ overall or local deflection and 1.0% tilt. This criteria, and my experience and judgment, was used to evaluate the performance of the foundation. Figure 1 below shows a graphical depiction of the actual deflection and tilt across the profile section A-A as shown on Drawing 1001.

- Across Section A-A, the maximum allowable localized deflection is $L/360" = 360"/360" = 1.0"$ and the actual deflection was measured to be $\approx 1.0"$. This foundation meets or exceeds the maximum allowable tolerance for localized deflection across Section A-A. There are indications of structural failure of the foundation to support the superstructure.
- Across Section A-A, the actual localized tilt was measured to be $\approx 1.15\%$. This foundation exceeds the maximum allowable tolerance for localized tilt across Section A-A.

7. **Conclusion: The actual deflection and tilt of the foundation is greater than the maximum allowable limits.** In my opinion, the magnitude and severity of the deflection, tilt and cosmetic indicators of movement warrant the need for structural foundation repairs at this time. This foundation is experiencing settlement (movement) that exceeds ASCE guidelines for performance.

10. **Recommendations:** It is recommended to install foundation lifting and supporting piers to return the foundation to a more level position. It is recommended to perform a structural crack repair on the cracking through the kitchen area.
