RE: Engineering Evaluation – Foundation Performance
Anywhere in North Texas

The following report constitutes the engineering opinion requested on the foundation of the subject residence. This report has been prepared in general accordance with the requirements of a "Level B" survey as defined by the Texas Chapter of the American Society of Civil Engineers (ASCE) and the Texas Board of Professional Engineers (<http://texasce.affiniscape.com/associations/10803/files/RepairGuidelines.pdf>).

Lighthouse Engineering, L.L.C.

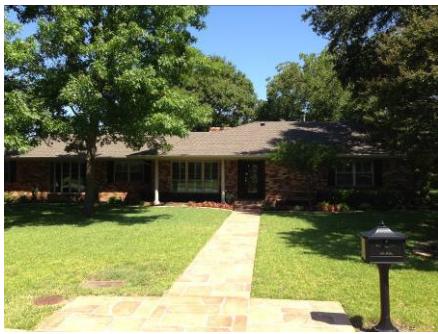
Photo 1: General view of the front of the home.

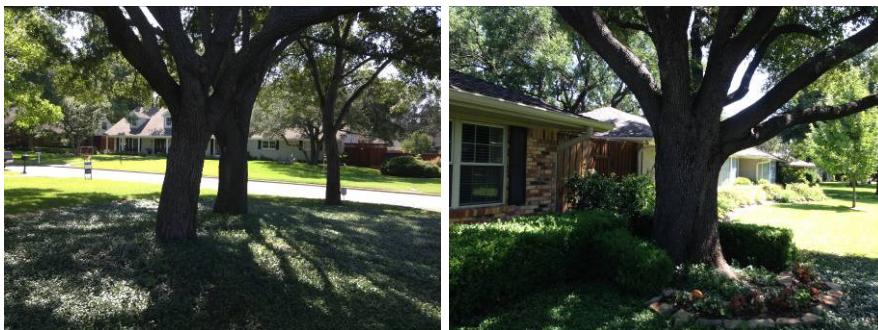
3. There were very few minor brickwork separations identified around the exterior of the home.
4. The perimeter of the home has gutters. It is recommended to routinely maintain gutters to ensure proper flow. The drainage around the home appeared to be adequate and no standing water was identified.
5. Large mature trees were identified in the front yard of the home.

Photos 2 & 3: Large mature trees located in the front yard.

1. Maintain a watering program in the dry months of the year to prevent the soil around the home from drying and cracking. If soaker hoses are used, place the soaker hoses 1' – 2' away from the foundation and run for 30 – 60 minutes every other day as needed. Do not over water the foundation; this can be as detrimental as under watering.

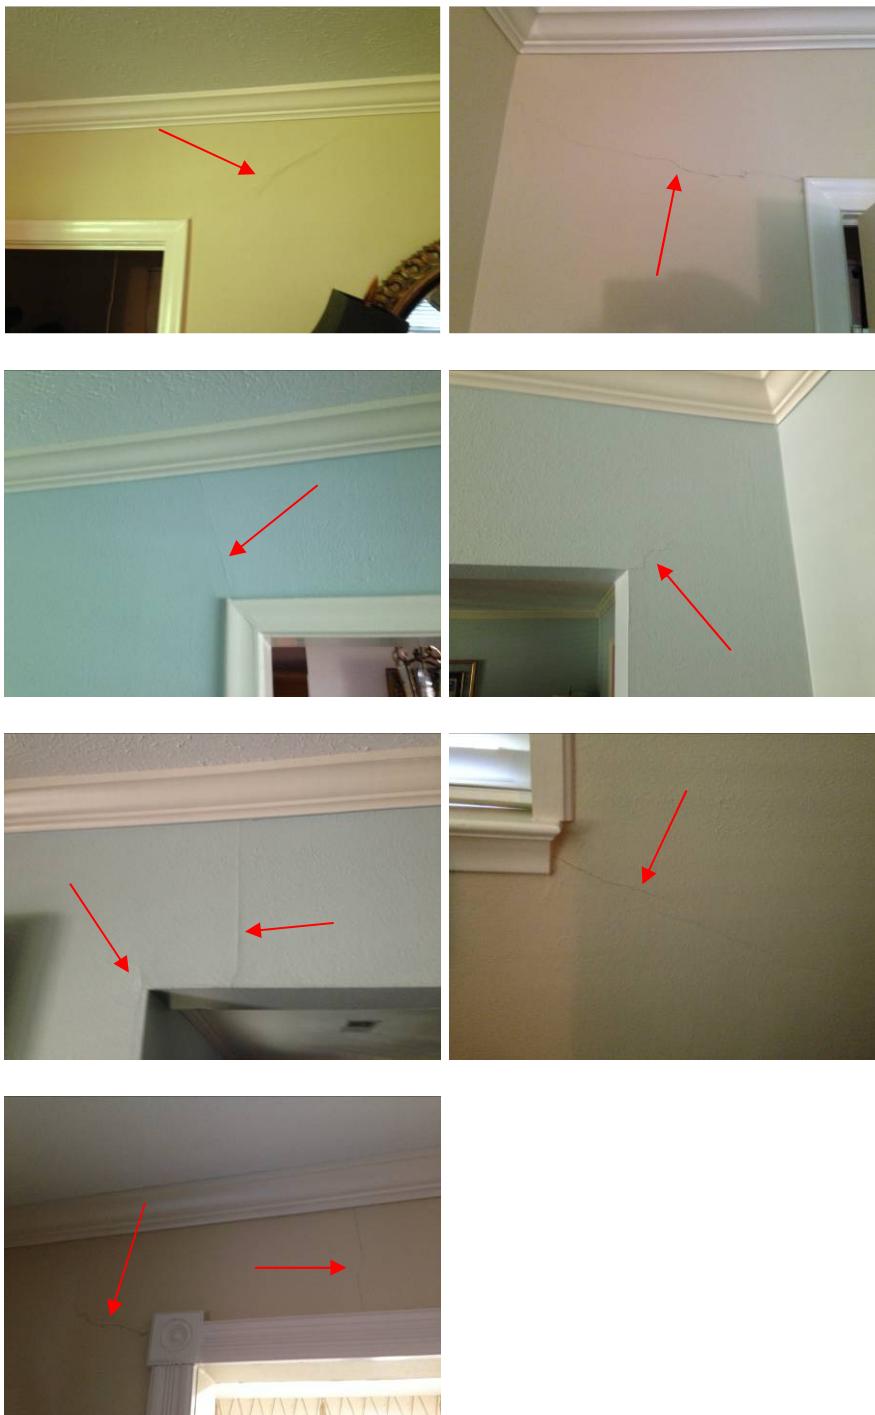
6. Numerous minor drywall separations were identified throughout the interior of the home. Most drywall separations appeared to be typical for a home of this age and location.

Photos 4 – 10: Minor drywall separations identified throughout the interior of the home.

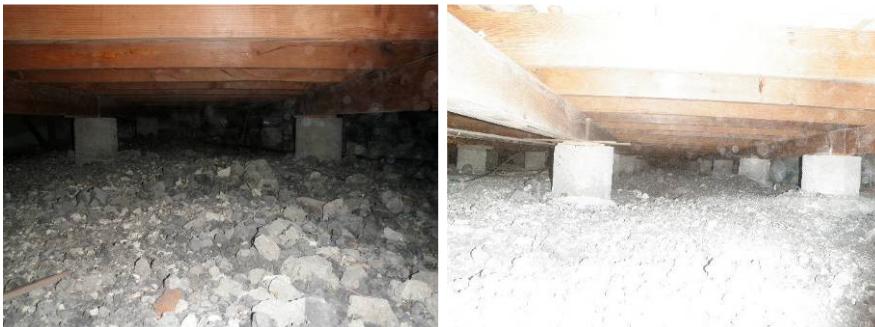
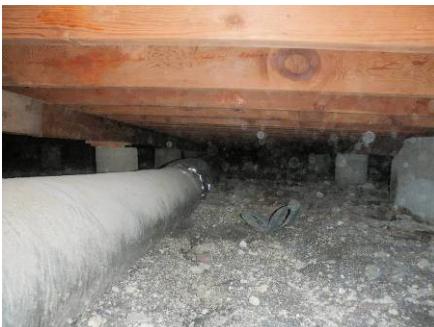
7. Soils beneath the home were clean and dry and ventilation appears to be adequate to allow for proper airflow beneath the home.

Photos 11 - 13: Views beneath the home.

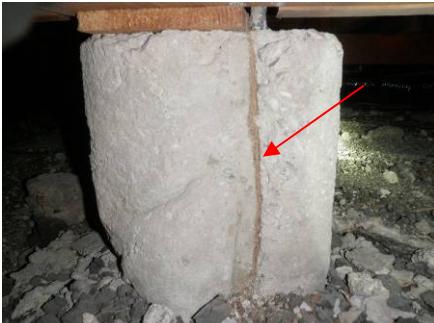
8. Minor signs of termite activity were identified in numerous locations beneath the home. No signs of active termite activity were identified at this time.

Photo 14: Signs of previous termite activity.

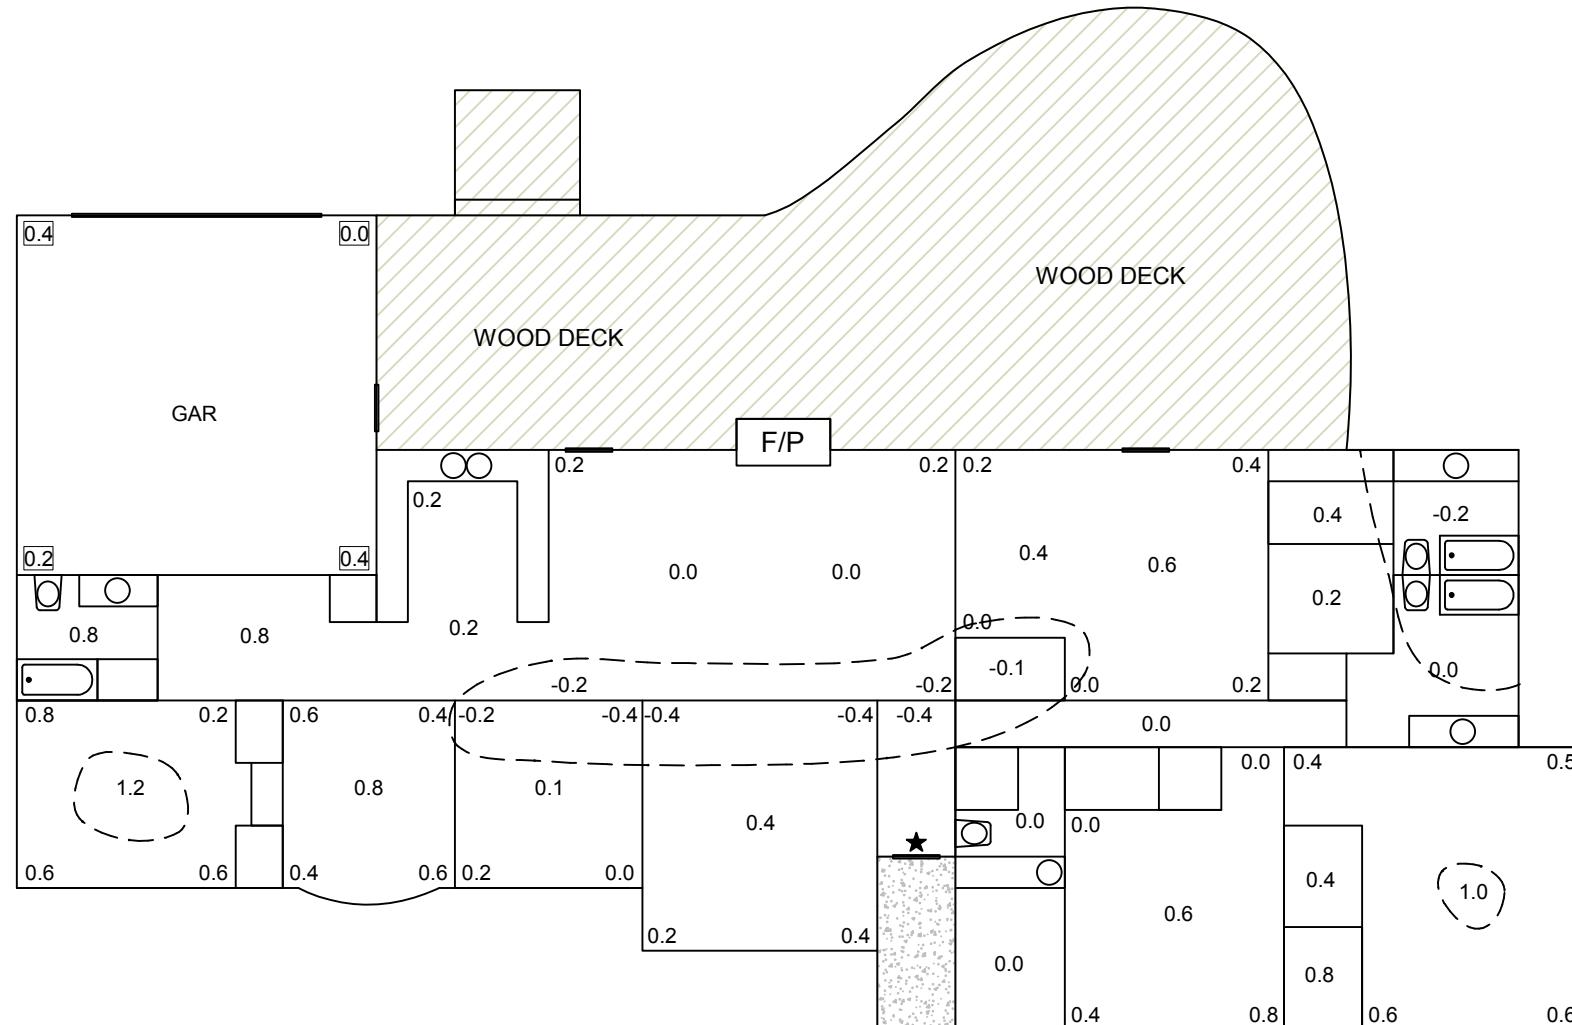
ADDRESS:	ANYWHERE IN NORTH TEXAS	FILE NO.:	XXXX2014	DATE:	DATE	DRAWING NO.	1001
----------	-------------------------	-----------	----------	-------	------	-------------	------

Interior floor elevations were taken with a Technidea Pro-2000 Ziplevel. Elevations were recorded to the nearest 0.1-inch throughout the home. A benchmark of 0.0 was established near the main entry area and is shown on Drawing No. 1001 with a star. An adjustment was made for floor coverings if they were a different elevation than the floor covering at the benchmark location. Elevation differentials varied by a maximum of 1.6 vertical inches in thirty-two (32) horizontal feet. It should be noted that the elevation measurements include effects of elevation variation in the original construction which normally are 0.6

inches to 1.0 inches. A sketch of the house with the elevations is attached as Drawing No. 1001.

An elevation survey was performed on the home and the cosmetic damage was reviewed to evaluate the performance of the foundation. The soil where the home is located has high shrink swell capacity. This soil can heave or settle depending on the moisture content in the soil. Some minor movement of the exterior driveways and sidewalks should be expected.
