RE: Initial Engineering Evaluation – Foundation Performance  
Anywhere in North Texas

# Lighthouse Engineering, L.L.C.

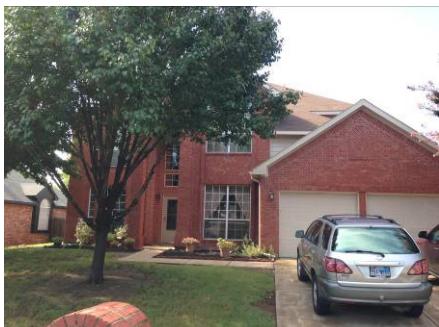
Photo 1: General view of the front of the home.

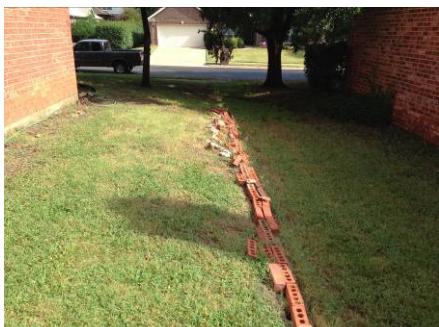
3. This engineer inspected the subject property after a rainfall event. The drainage around the home appeared to be adequate and no standing water was identified.
4. The home is situated on a cut and fill lot with the ground sloping from rear to front and right to left generally.

Photo 2: View along the left side of the home.

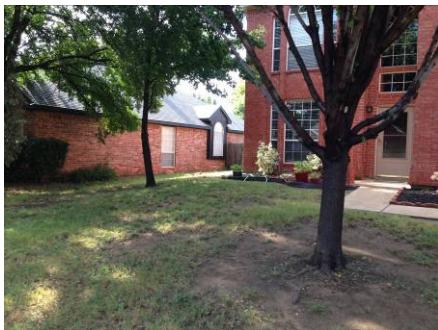
5. Large mature trees were identified in the front yard. These trees do not appear to be directly affecting the performance of the home's foundation at this time.

Photo 3: Large mature trees identified in the front yard.

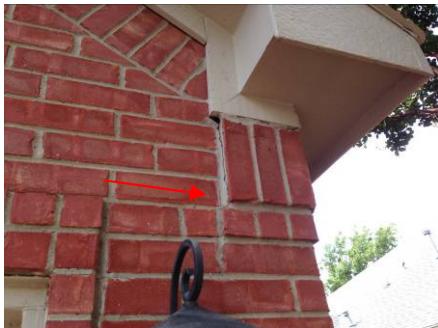
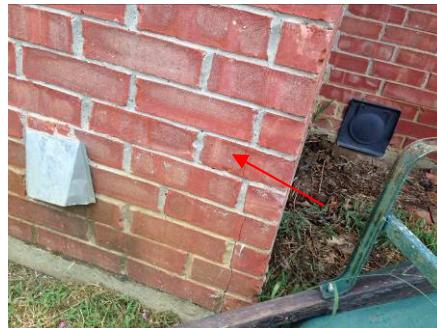
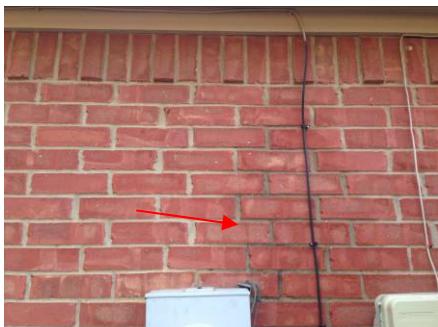
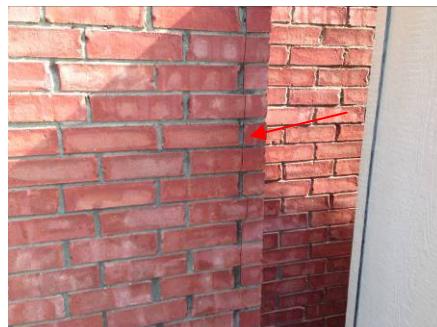
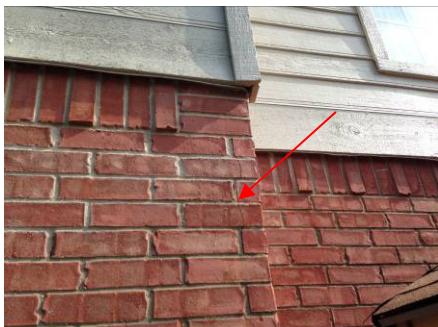
6. Minor brickwork separations were identified around the exterior of the home. These separations appeared to be due to thermal expansion in the home's framing and seasonal movement in the home's foundation. These separations are not indicative of significant foundation movement and no structural repairs are recommended at this time.

Photos 4 - 8: Minor brickwork separations identified.

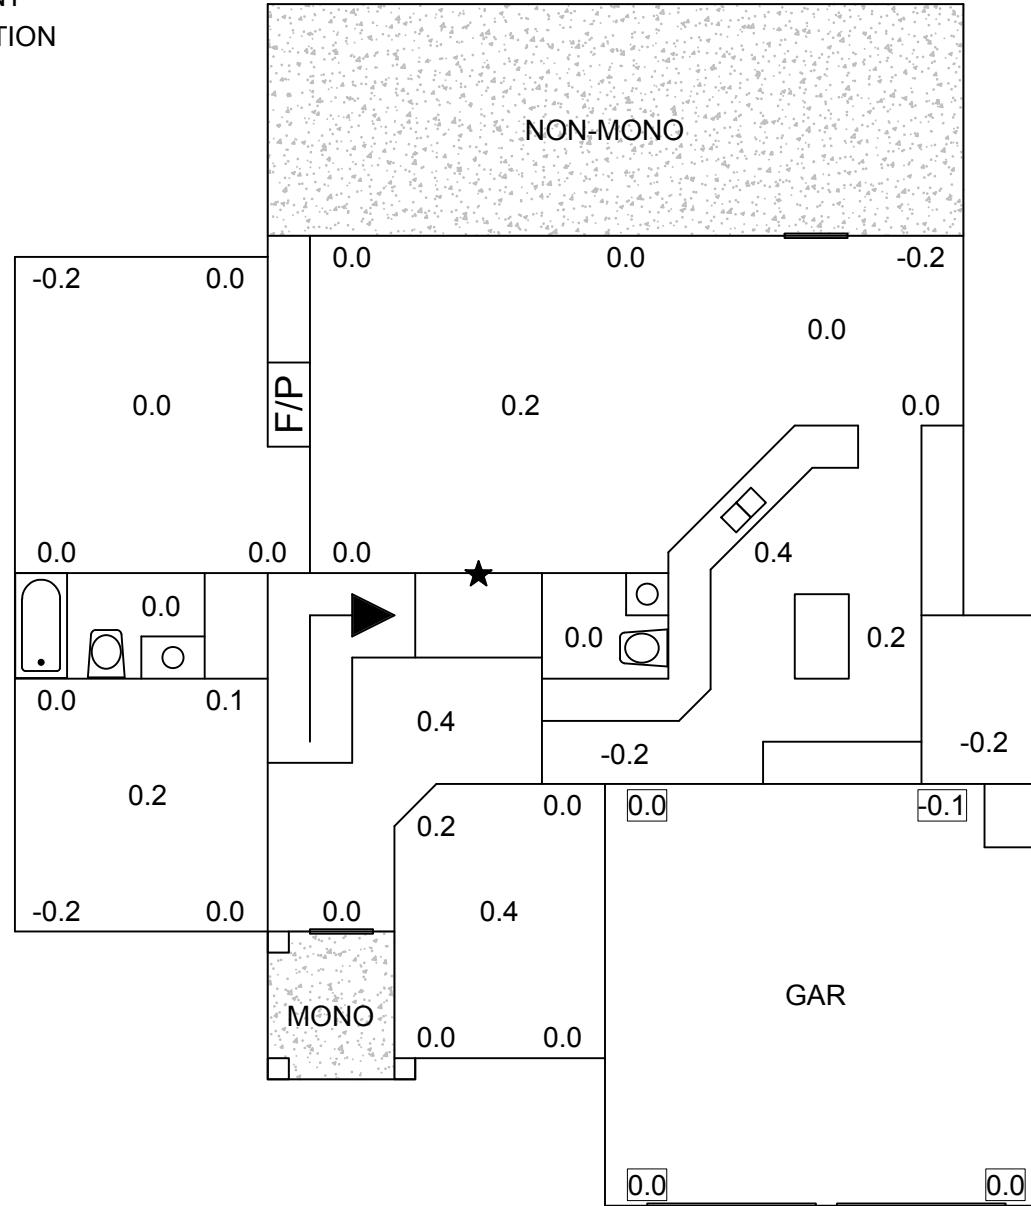
★ BENCHMARK ELEVATION 0 INCHES  
ELEVATIONS ARE SHOWN IN TENTHS OF AN INCH  
**ELEVATION SURVEY DRAWING**

Interior floor elevations were taken with a Technidea Pro-2000 Ziplevel. Elevations were recorded to the nearest 0.1-inch throughout the home. A benchmark of 0.0 was established in the center of the home and is shown on Drawing No. 1001 with a star. An adjustment was made for floor coverings if they were a different elevation than the floor covering at the benchmark location. Elevation differentials varied by a maximum of 0.4 vertical inches in seven (7) horizontal feet. It should be noted that the elevation measurements include effects of elevation variation in the original construction which normally are 0.6 inches to 1.0 inches. A sketch of the house with the elevations is attached as Drawing No. 1001.

Reviewing the elevation survey, the home does not have any slopes in the foundation that are above acceptable tolerances for slope. There are no foundation repairs recommended, at this time. Some minor movement of the foundation has occurred since the home was built. The amount of movement is within acceptable tolerance as foundations are designed to allow for minor movement.
