RE: Initial Engineering Evaluation – Foundation Performance  
Anywhere in North Texas

## Observations and Discussions:

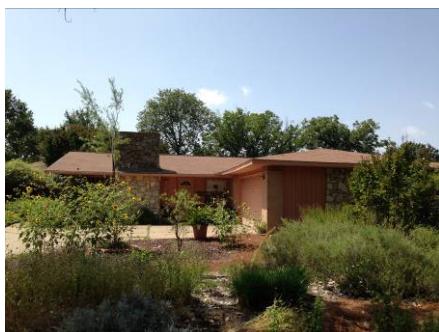
Photo 1: General view of the front of the home.

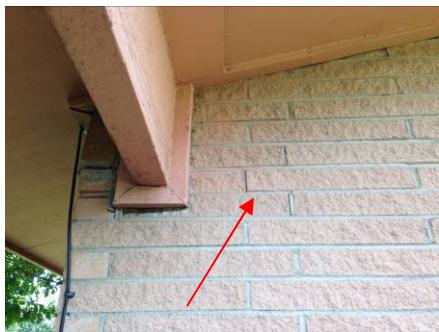
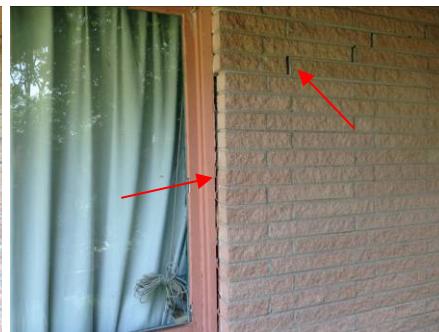
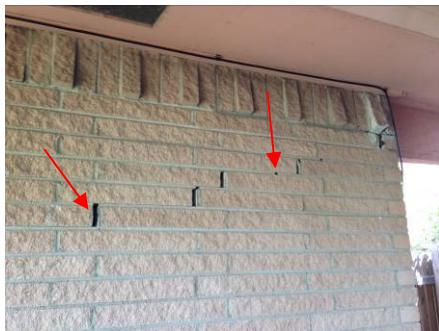
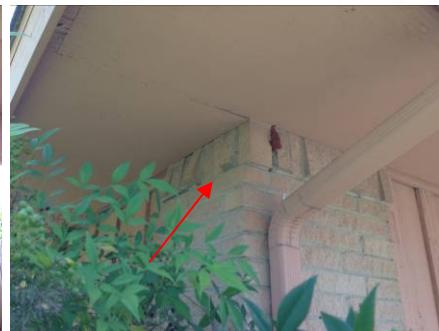
3. Numerous brickwork separations and frieze-board separations were identified around the home. Loose bricks were noted at multiple corners of the home.

Photos 2 – 5: Brickwork separations and loose bricks identified around the home.

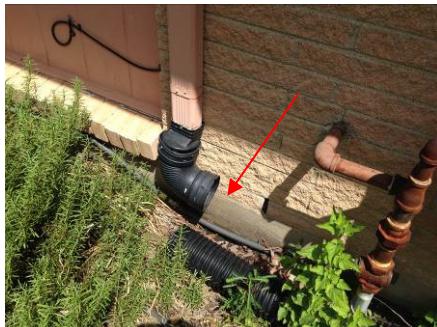
4. A gutter downspout located along the rear of the home was noted to be discharging into a disconnected perforated pipe. It is recommended to remove this perforated pipe and replace the pipe with a solid gutter extension. Extend all gutters at least 36" away from the home's foundation.

Photo 6: Disconnected gutter downspout along the rear of the home.

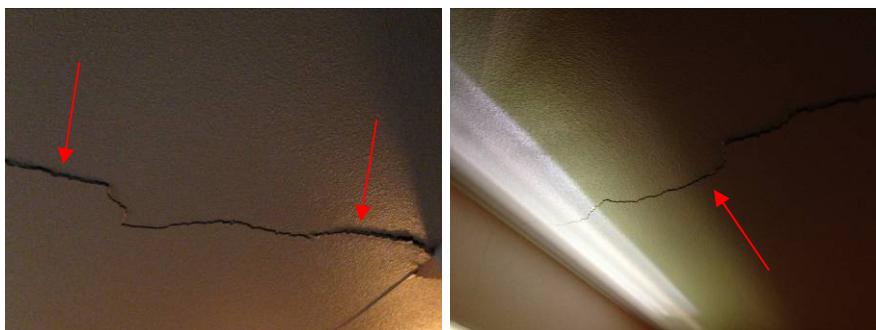
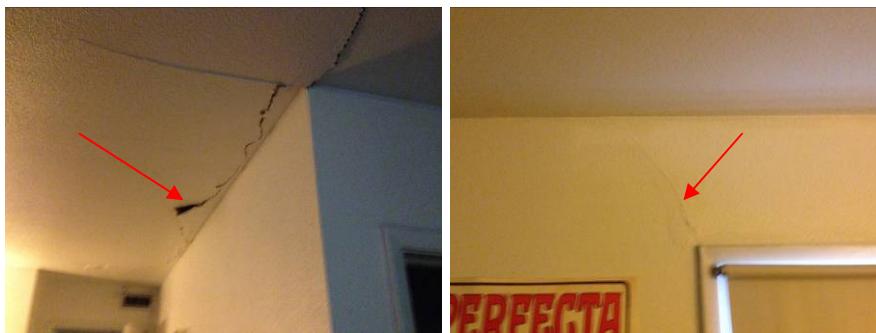
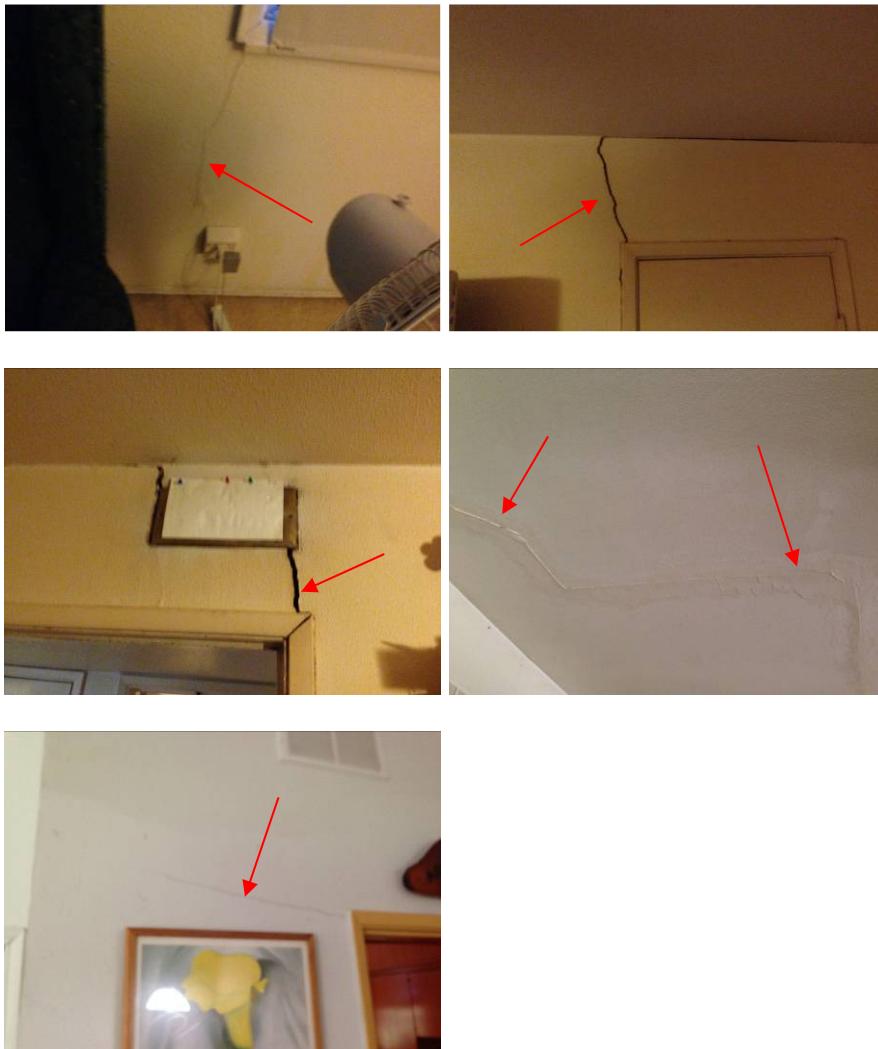
5. Slopes in the floor were noticeable when walking across numerous rooms along the rear portions of the home. The most noticeable sloping was identified in the master bedroom area.
6. Numerous drywall separations were identified throughout the interior of the home. The largest separations were noted in the master bedroom and bathroom area ceilings.

Photos 7 – 15: Drywall separations identified throughout the interior of the home.

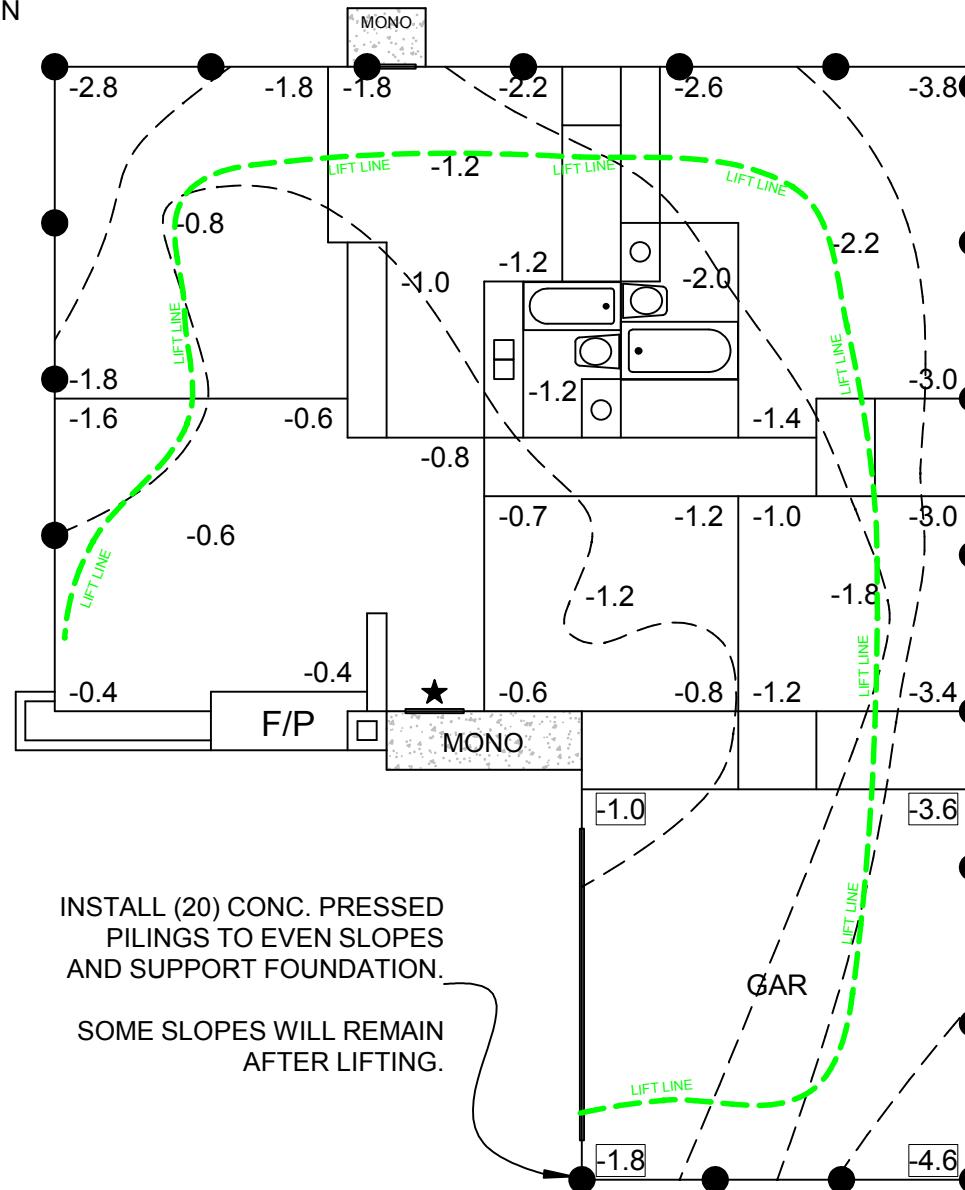
ELEVATION SURVEY DRAWING

Interior floor elevations were taken with a Technidea Pro-2000 Ziplevel. Elevations were recorded to the nearest 0.1-inch throughout the home. A benchmark of 0.0 was established in the main entry area and is shown on Drawing No. 1001 with a star. An adjustment was made for floor coverings if they were a different elevation than the floor covering at the benchmark location. Elevation differentials varied by a maximum of 4.6 vertical inches in thirty-five (35) horizontal feet. It should be noted that the elevation measurements include effects of elevation variation in the original construction which normally are 0.6 inches to 1.0 inches. A sketch of the house with the elevations is attached as Drawing No. 1001.

Reviewing the distress and the elevation survey the home is concluded to have settlement around the exterior of the foundation. The settlement in the foundation appears to be due to the moisture content in the soil lowering over time. As the moisture content in the soil is lowered the soil can consolidate and settle under the pressure of the above structure. Foundations are supported by the soil, and if the soil settles unevenly, the foundation may move unevenly resulting in structural distress and slopes in the foundation.

1. Install twenty (20) Concrete Pressed Piling Piers in the locations shown on attached Drawing No. 1001 and to the pier specifications listed below. Piers are intended to reduce the slopes in the foundation, alleviate structural distress, and prevent future settlement in the area they installed. A pier plan showing the recommended locations is attached to this report (see Drawing No. 1001). After the piers are installed, the slopes in the home should be reduced to the most practical extent possible.
