LIGHTHOUSE ENGINEERING, L.L.C.

RE: Initial Engineering Evaluation – Foundation Performance
1234 Main Street
Dallas, Texas 75109

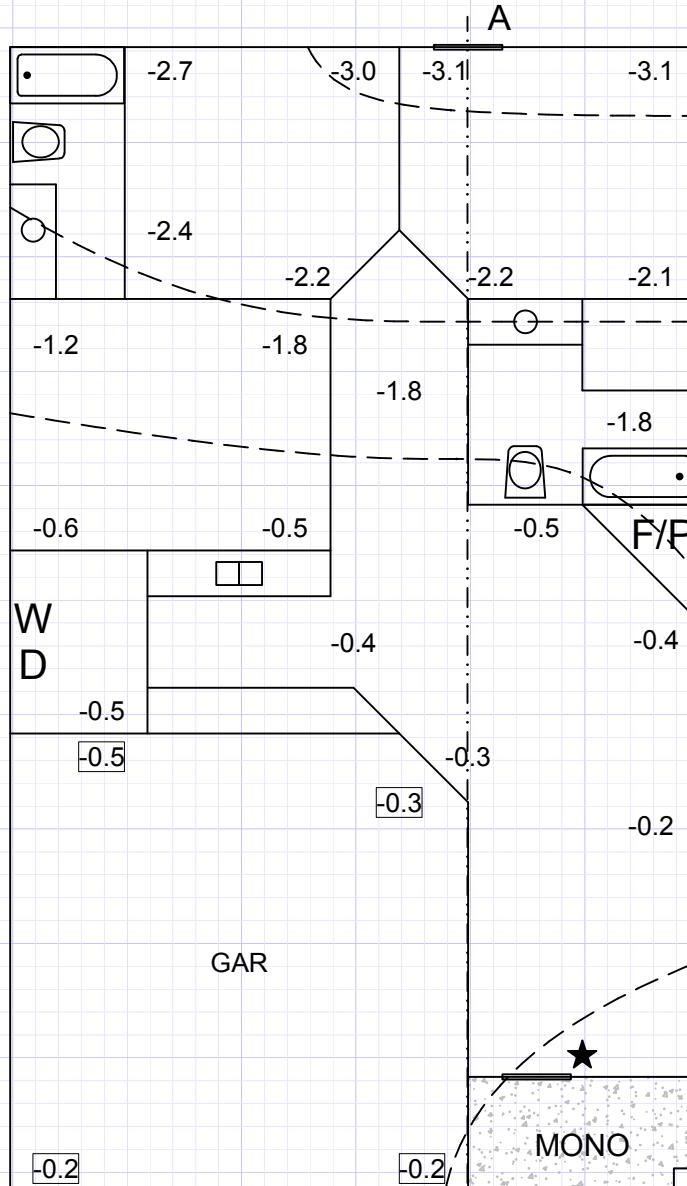
★ BENCHMARK ELEVATION 0 INCHES
ELEVATIONS ARE SHOWN IN TENTHS OF AN INCH
ELEVATION SURVEY DRAWING

7. **Conclusion: The actual deflection and tilt of the foundation is greater than the maximum allowable limits.** In my opinion, the magnitude and severity of the deflection, tilt and cosmetic indicators of movement warrant the need for structural foundation repairs at this time. This foundation is experiencing settlement (movement) that exceeds ASCE guidelines for performance.

- There is concrete cracking that indicates structural failure of the concrete slab and post tension re-enforcement. The foundation is no longer capable of supporting the superstructure.
- The magnitude and severity of the deflections and tilts in the foundation are causing load bearing components to be unsafe, unsanitary, or otherwise unlivable.

10. **Recommendations:** It is recommended to install foundation lifting and supporting piers to return the foundation to a more level position. It is recommended to perform a structural crack repair on the cracking through the kitchen area.
