RE: Engineering Evaluation – Foundation Performance
Anywhere in North Texas

The following report constitutes the engineering opinion requested on the foundation of the subject residence. This report has been prepared in general accordance with the requirements of a "Level B" survey as defined by the Texas Chapter of the American Society of Civil Engineers (ASCE) and the Texas Board of Professional Engineers (<http://texasce.affiniscape.com/associations/10803/files/RepairGuidelines.pdf>).

Lighthouse Engineering, L.L.C.

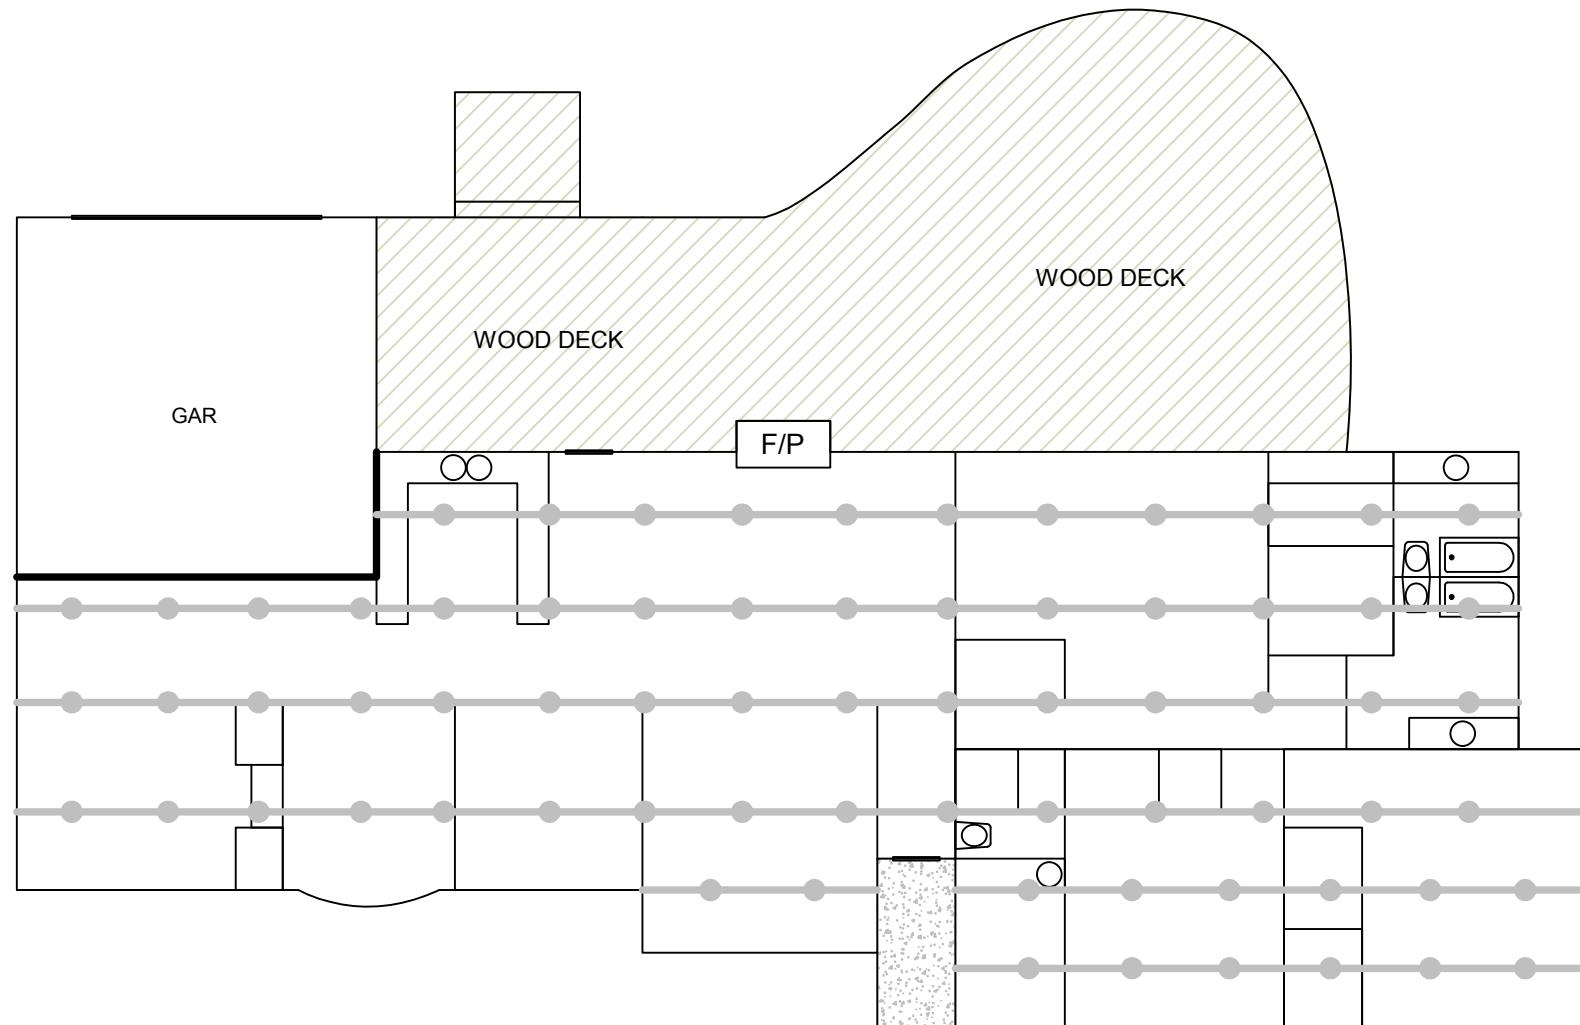
Interior floor elevations were taken with a Technidea Pro-2000 Ziplevel. Elevations were recorded to the nearest 0.1-inch throughout the home. A benchmark of 0.0 was established near the main entry area and is shown on Drawing No. 1001 with a star. An adjustment was made for floor coverings if they were a different elevation than the floor covering at the benchmark location. Elevation differentials varied by a maximum of 1.6 vertical inches in thirty-two (32) horizontal feet. It should be noted that the elevation measurements include effects of elevation variation in the original construction which normally are 0.6
